REPORT
OF
THE
ONE-MAN
PRESIDENTIAL COMMISSION OF INQUIRY
APPOINTED
TO
INVESTIGATE
THE LEAKAGE OF WATER
FROM THE
SAMANALAWEWA RESERVOIR

COMMISSIONER : J F A SOZA
27 OCTOBER 1993

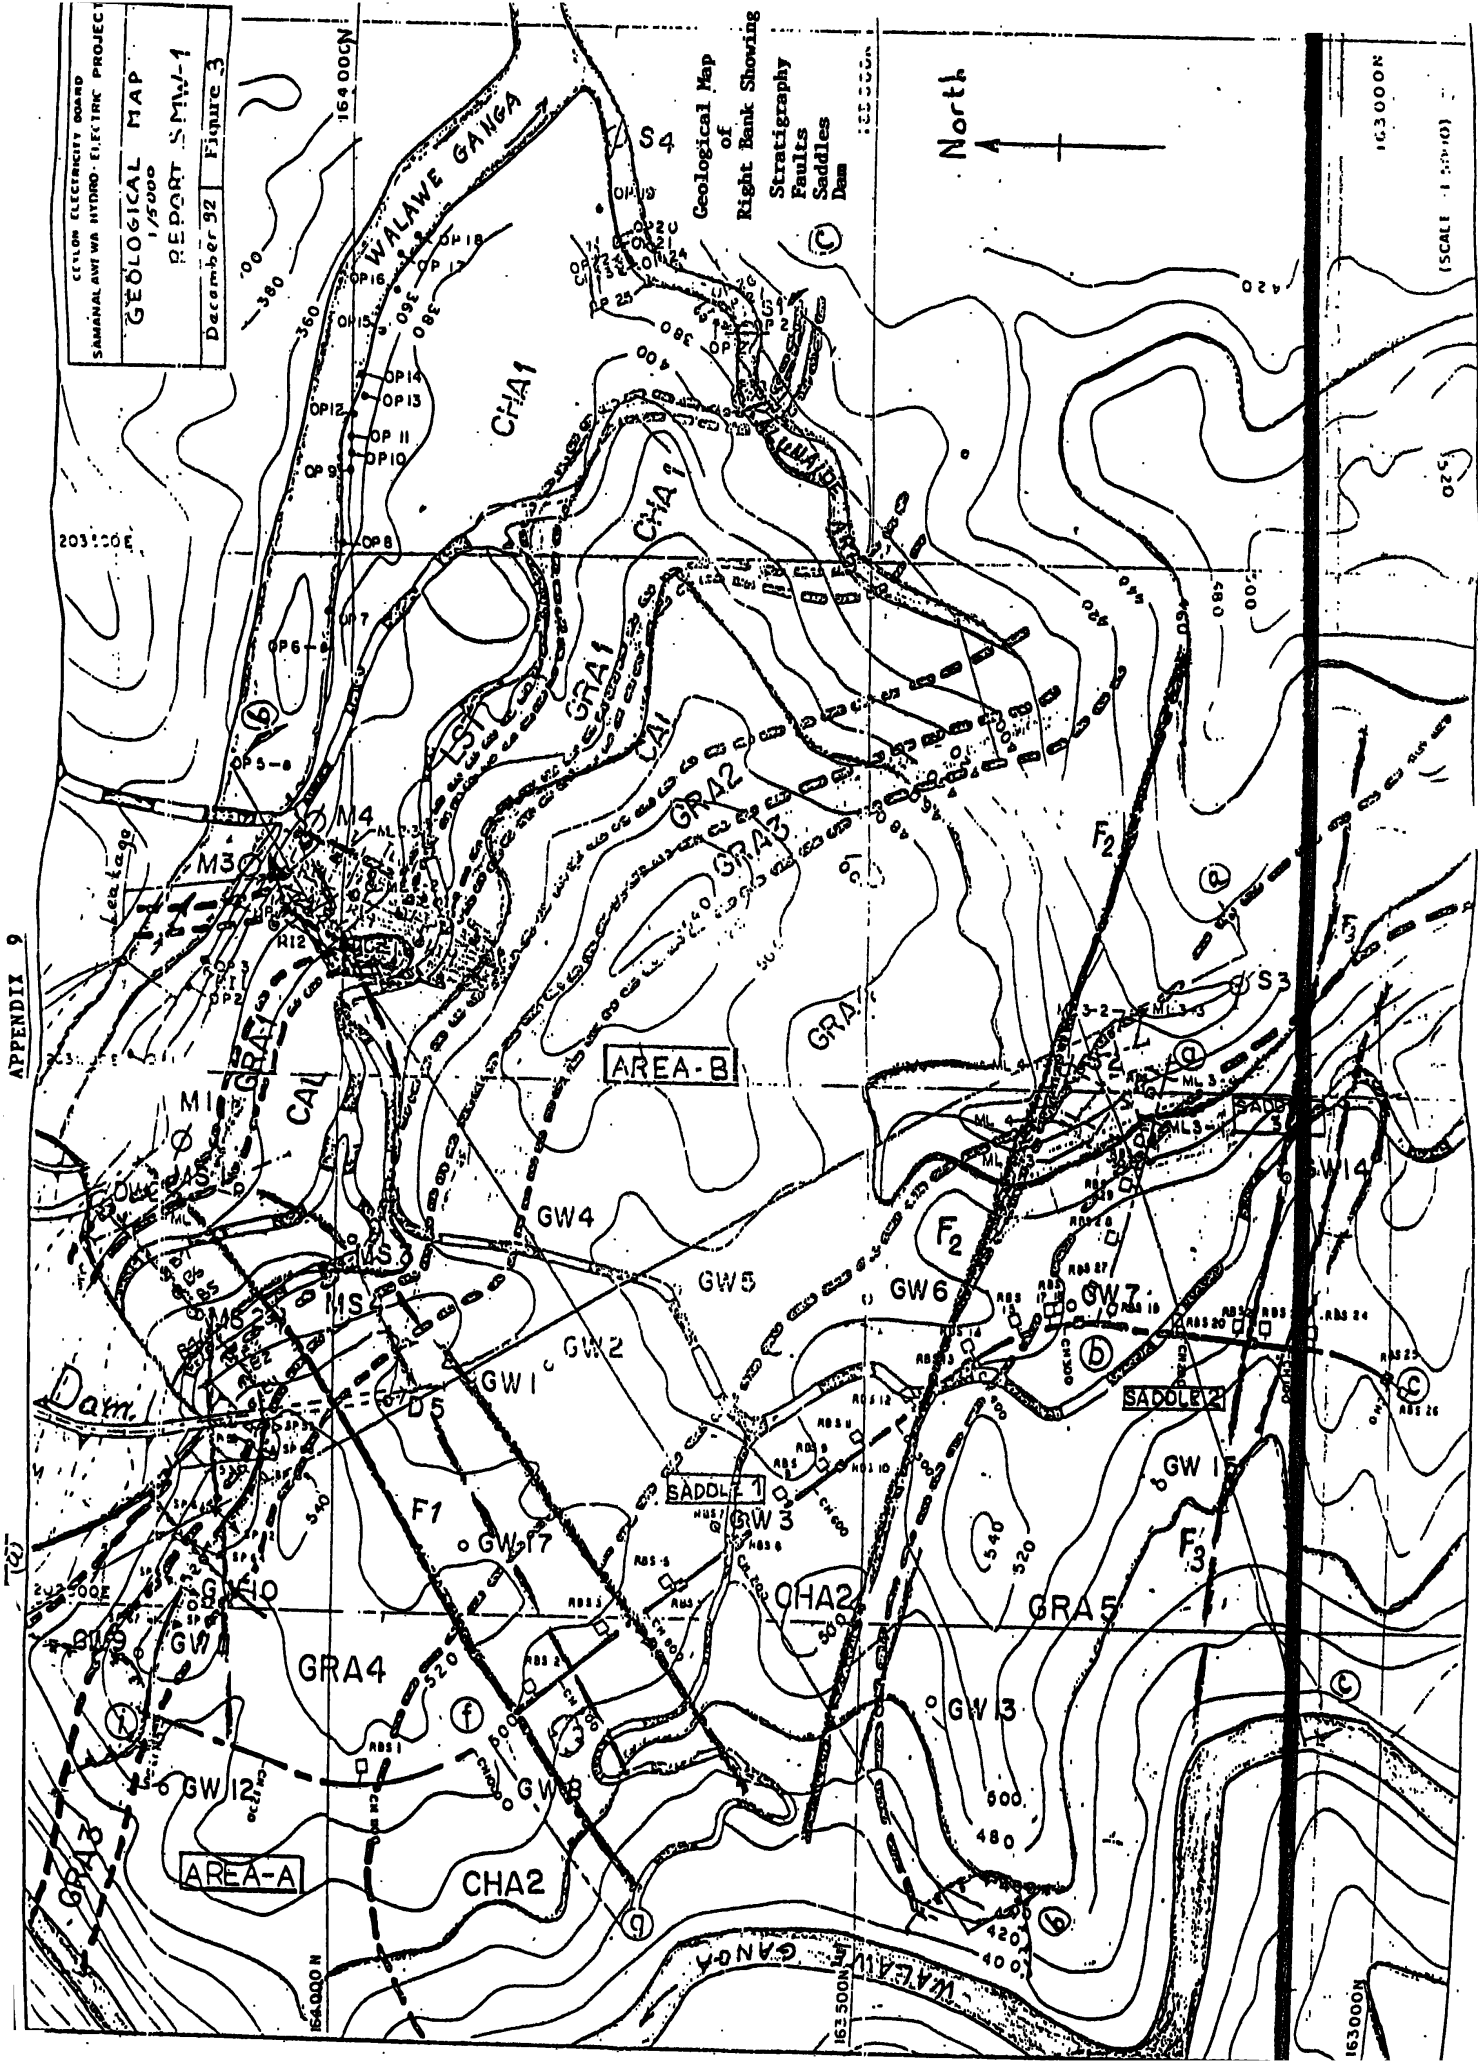
CYLON ELECTRICITY BOARD
 SAMANALAWA HYDRO-ELECTRIC PROJECT
 GEOLOGICAL MAP
 1/5000
 REPORT SMW-1
 December 92 Figure 3

Geological Map
 of
 Right Bank Showing
 Stratigraphy
 Faults
 Saddles
 Dam
