SAMANALAWEWA HYDROELECTRIC PROJECT

THIRD PARTY REVIEW PANEL

REPORT SMW-1

MAIN CONCLUSIONS AND RECOMMENDATIONS

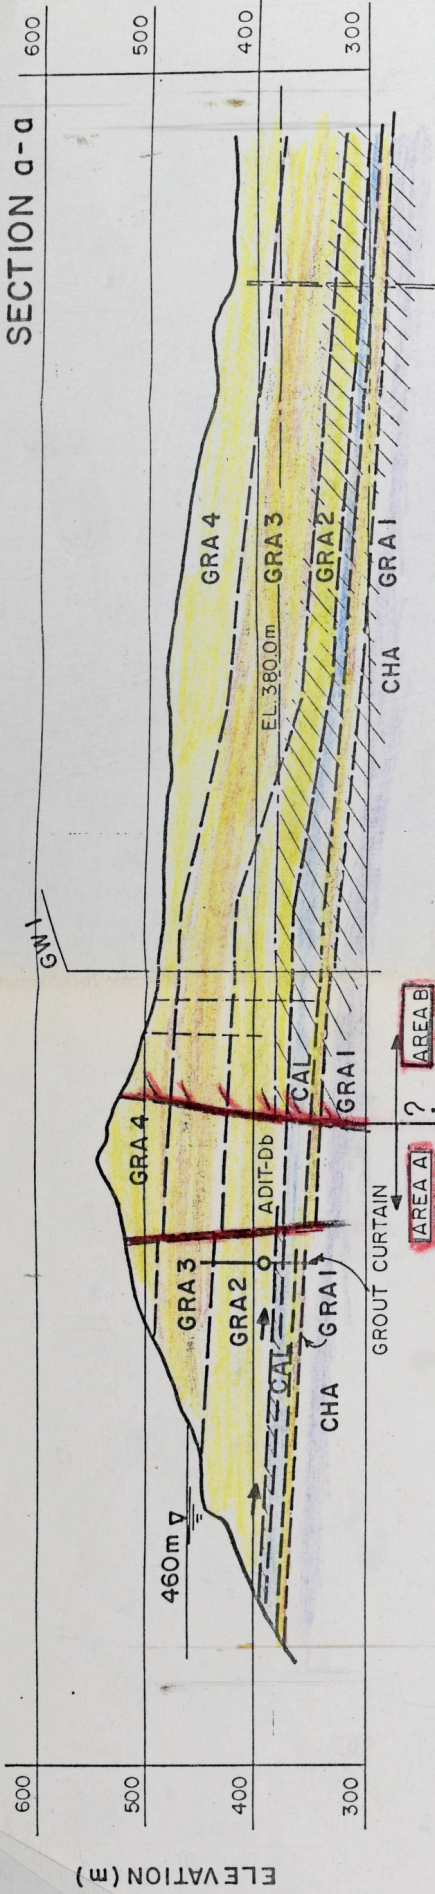
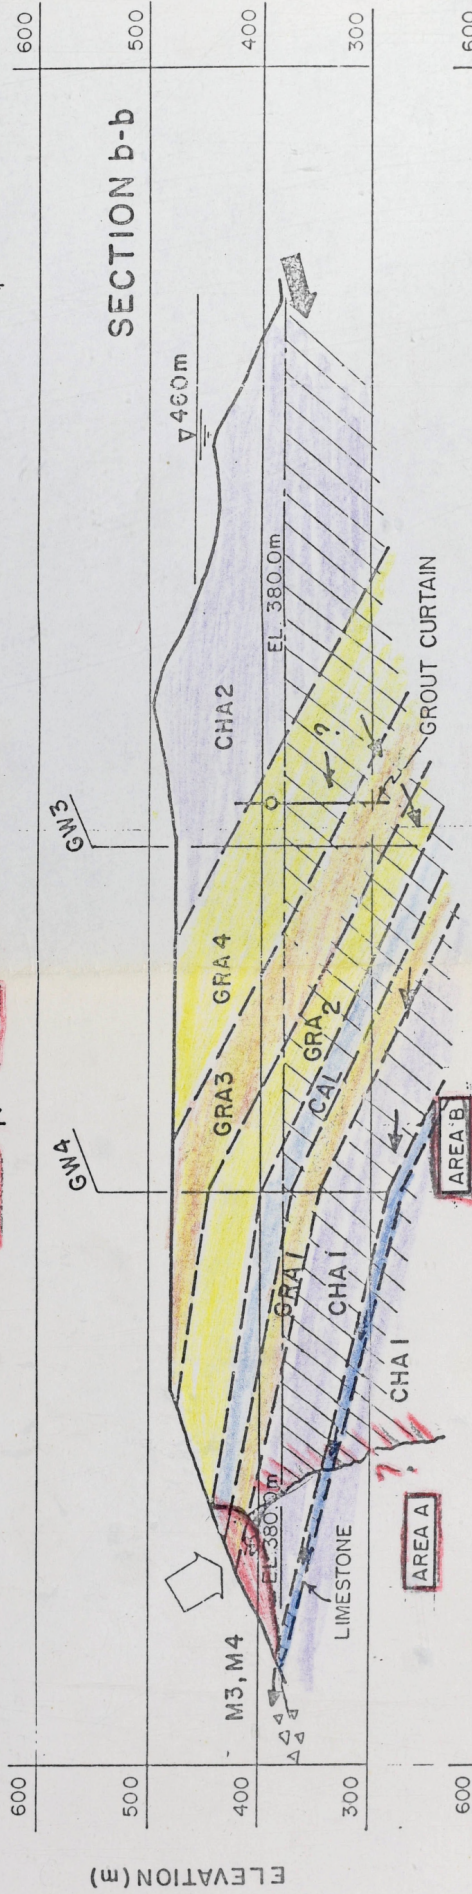
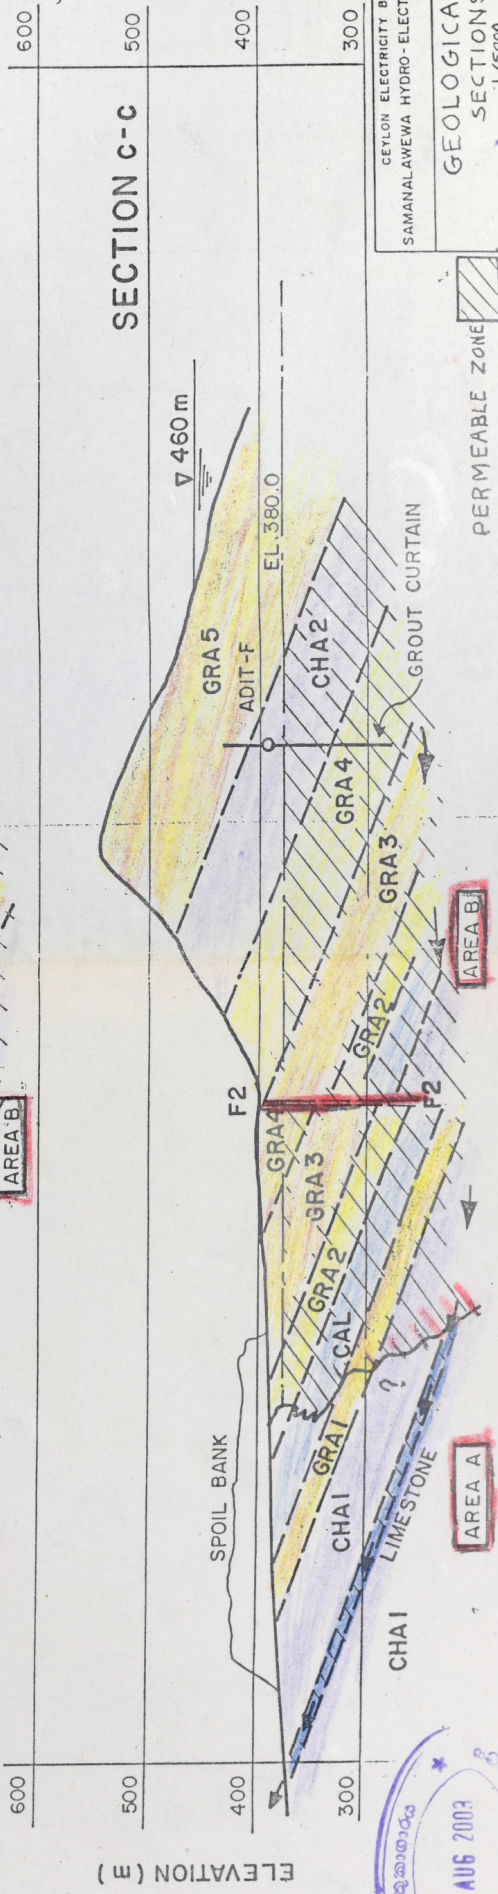
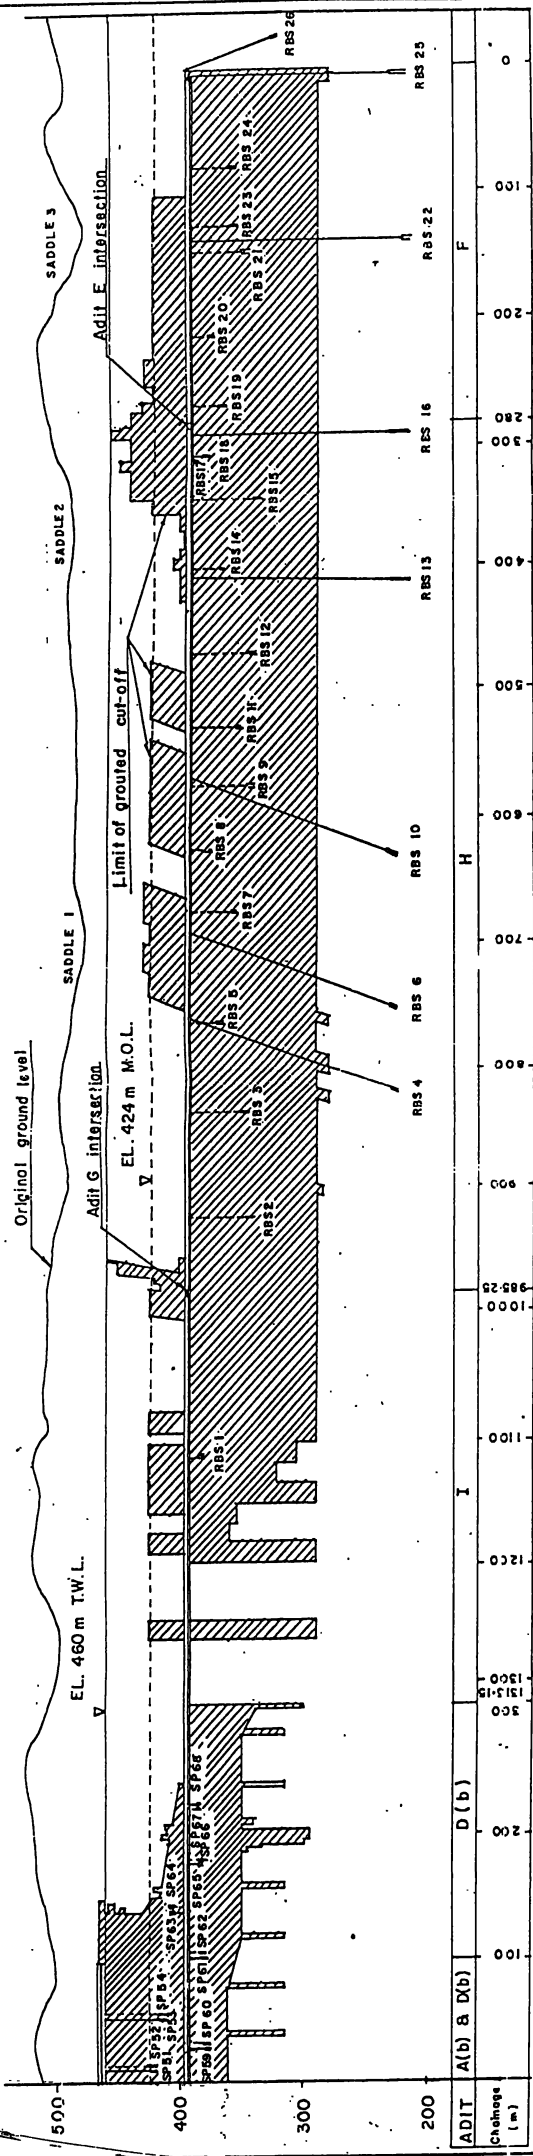
FIGURE 6

Only very few spots have been grouted above the adit up to El. 424 and rarely to El. 460 (see figure 6), taking into account the geological data collected in the adit (areas with open fractures, fault and shear zones) but it is not sure that ungrouted windows have not been left. Certain sections between CH 1200 and CH 1315 have not been grouted, being considered impervious. Check holes or observation wells equipped with a slotted plastic pipe should be drilled to control this extrapolation. Grouting has reduced the void ratio of the curtain by up to 95 %.

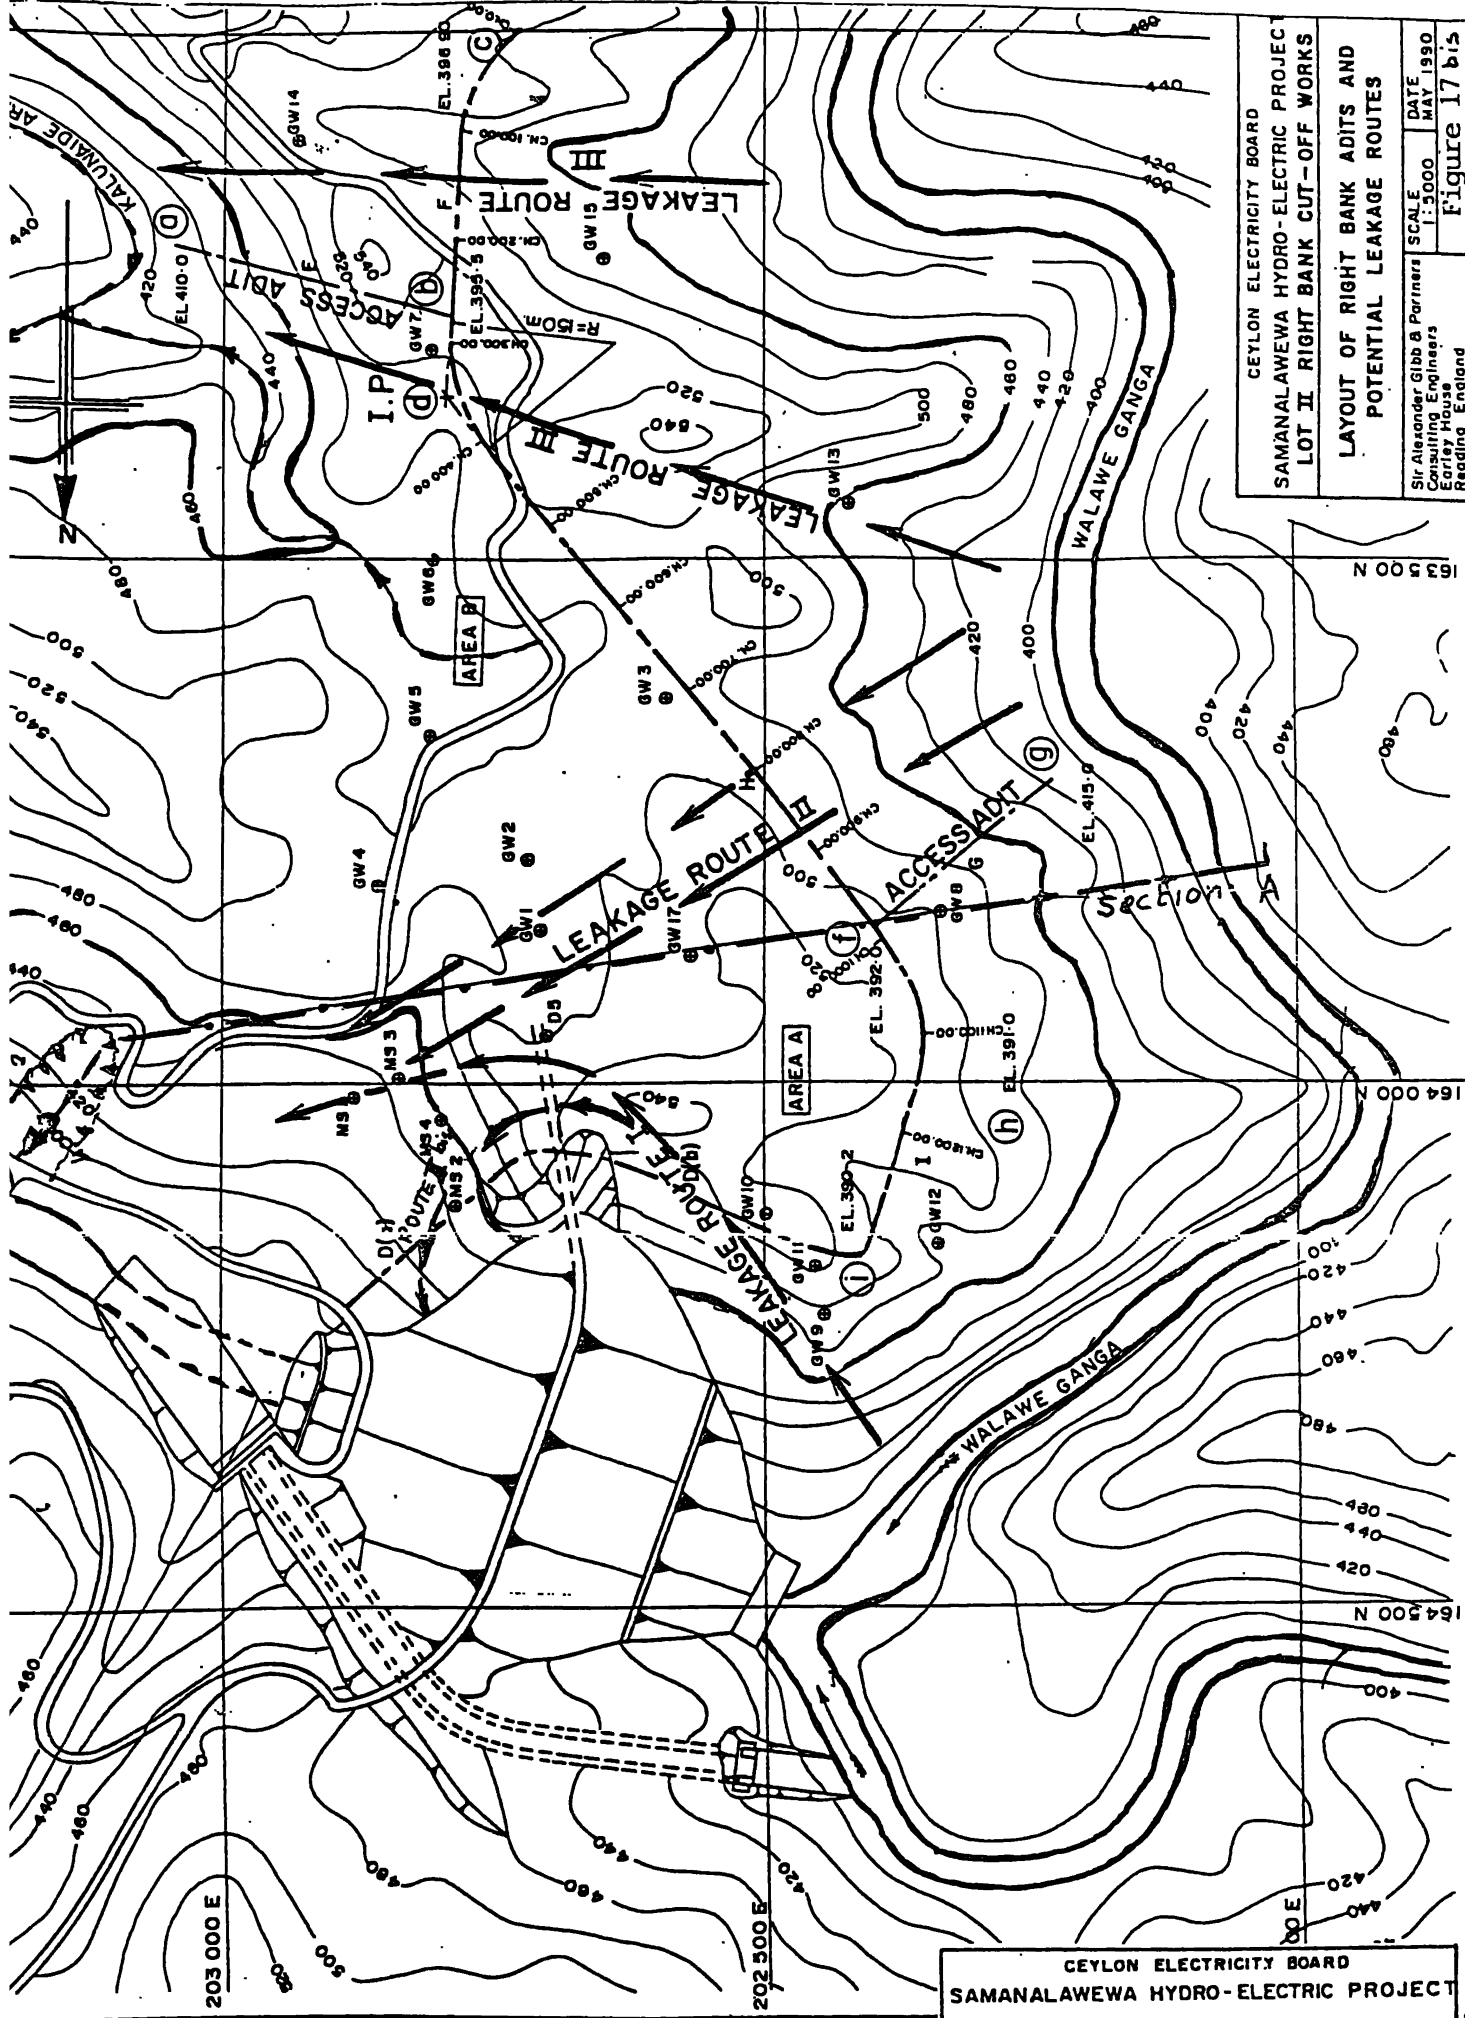
REPORT SMW.1
 30 December 92 | Figure 6 bis

Special attention should be paid to the evolution of piezometers in the immediate vicinity of the Dam Right abutment which can be by-passed by the leakage route I bis (see figure 6 bis) using shear joints and tensional fracture joining Fault system F₁. It should be noted that certain of the piezometers (see document C annex fig. J-10 and J-11) placed upstream and downstream of the grout curtain Db have been affected

To conclude, it can be said that there are many concurring facts which permit one to consider that there is a leakage path around the right abutment connected to the aquifer and closer to the dam than it was assumed. This assumption should be kept in mind in the design of the remedial measures to the high leakage of October 1992, which should take into account the maximum reservoir operating level (460), i.e. more than 20 m above the level attained during the October 1992 impounding.

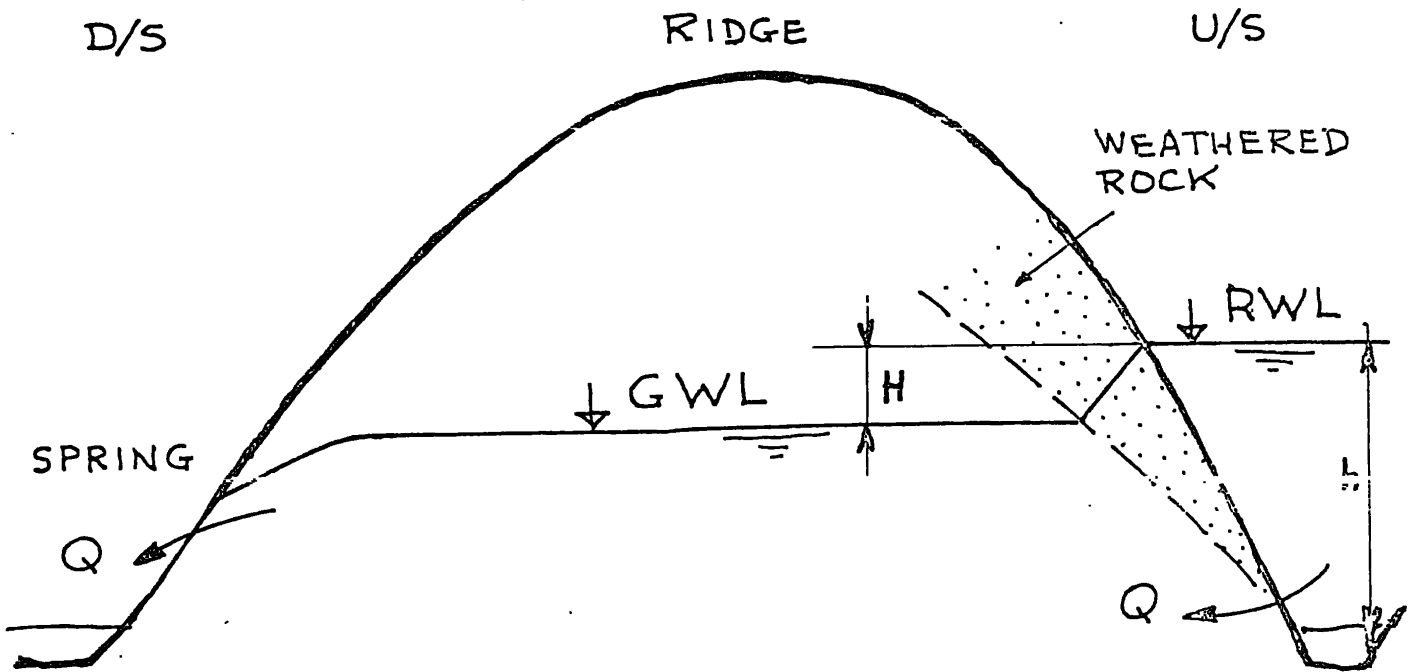
SAMANALAWEVA
Report SMW-1
Annexe 2 - Figure 2
RIGHT BANK LEAKAGE

A 31.10.92	B 09.11.92	C 03.12.92
Q(m ³ /s)	3.0	2.5	1.8
RWL(m)	433.5	431.0	427.5
GWL(m)	420.5	420.0	419.5
