Environmental Impact Assessment of Clay Extraction and Blanketing of Samanalawewa Reservoir for Leakage Mitigation

Ceylon Electricity Board

July, 1994

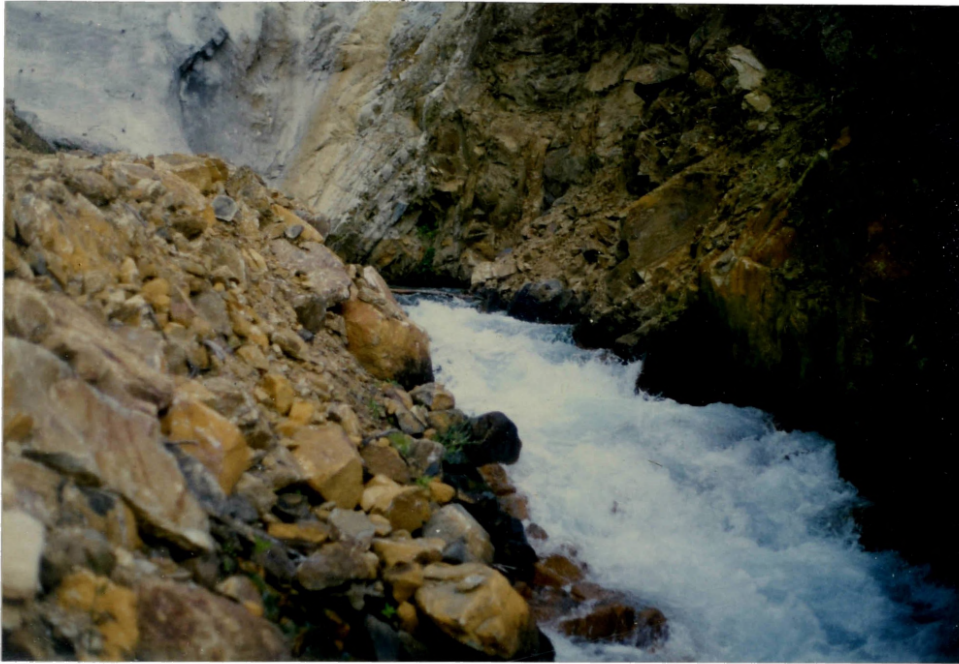
Plate 1: Leakage Point at Matihakka

Current leakage is through a fold on the Matihakka fault which serves as the best system of pore pressure relief. There is no need for any further drainage, provided the remedial action proposed is implemented.

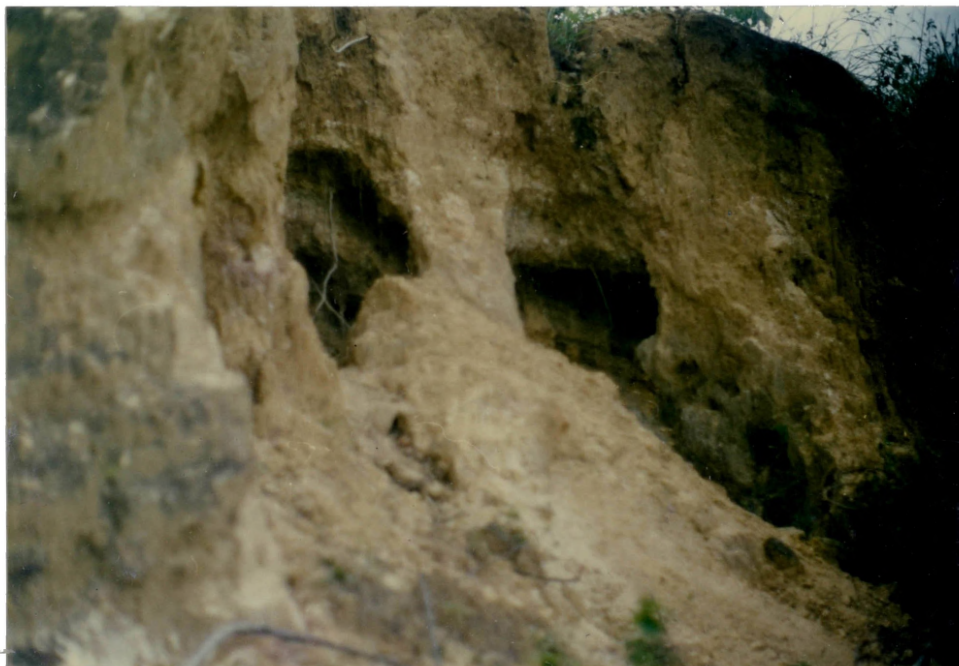
Plate 2: Karst Caverns on Reservoir Periphery
