**Contrasting an Effective Human Causes to Landslides
Using GIS Technology**

Thesis submitted in partial fulfillment of the requirement for the

Natural Resources

Department of Natural Resources
Faculty of Applied Sciences
Sabaragamuwa University of Sri Lanka
Buttala, 91100
Sri Lanka.

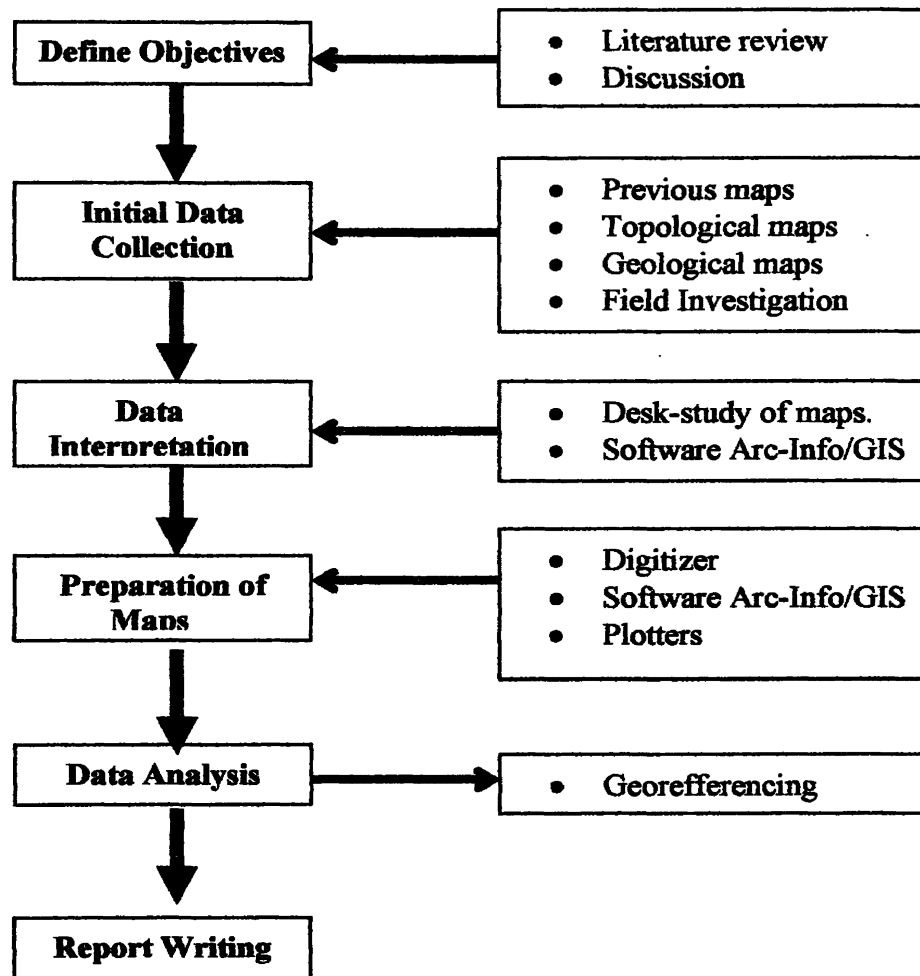
Figure 3.4 : Flow of Events in Methodology.

The Materials & Methodology Illustration can be concisely defined using the following chart of flow events. (Figure 3.4)

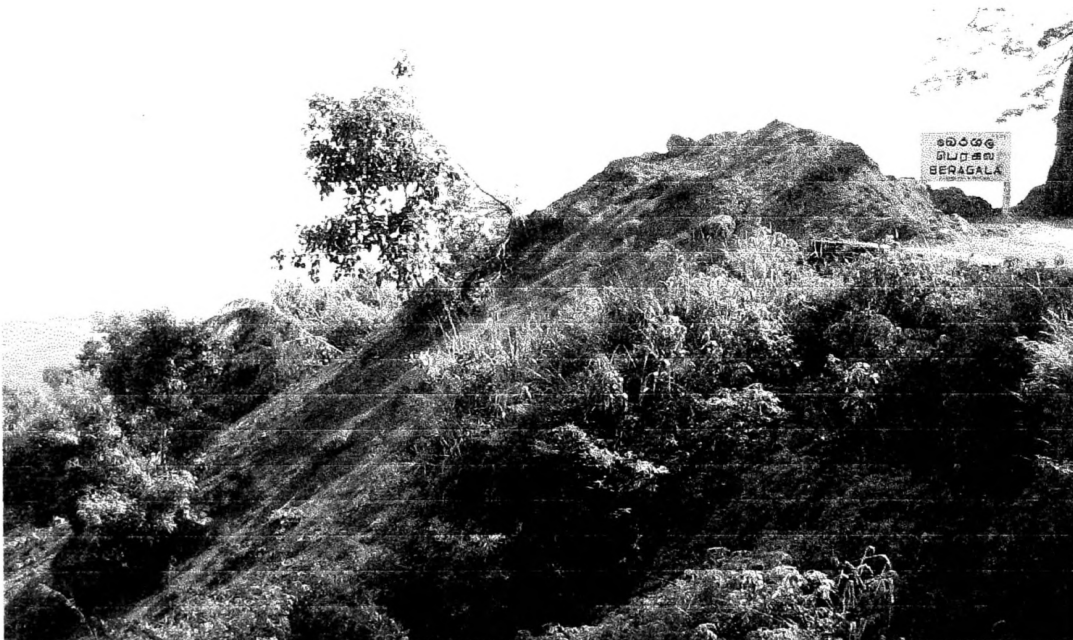
Plate 4.1 :- A land fill site where the filled earth is not properly compacted

Uncontrolled encroachment of state lands by the landless rural poor is a very prevalent phenomenon. The state lands that are on hill slopes are covered with jungles. Clearing the steep slopes and fill the slope without proper retaining system is practiced by these impoverished villagers and has become a major contributory factor for this disaster.

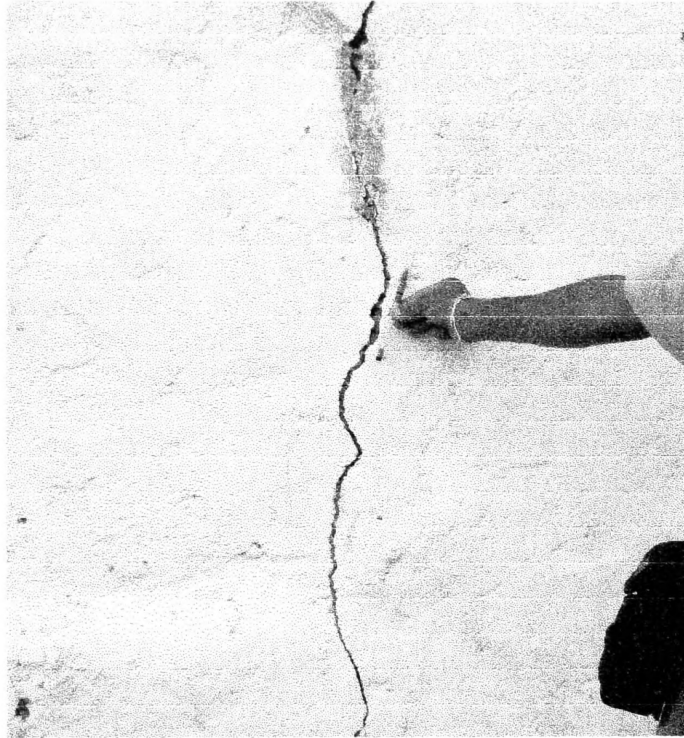
Plate 4.3 :- A fracture observed on the wall of a line cottage

The population in the region has increased rapidly and the availability of land for agriculture has dwindled to the extent that the population is unable to live solely by the land. Consequently, the emergence of other means of supplement whatever is obtained from the small extents of available land. The field investigation encountered future threat on land. Most of the line houses/line of cottages are built in the middle part of the slope. Vertical cuts without earth retaining structures have been observed on the rear side of most houses. Those houses have no proper drainage facilities to direct rainwater away from the slopes. Minor slope failures have been observed behind the observed line of cottages. These failures spread further and form wall-cracks on the walls and the floor of the cottages. (Plate 4.3)

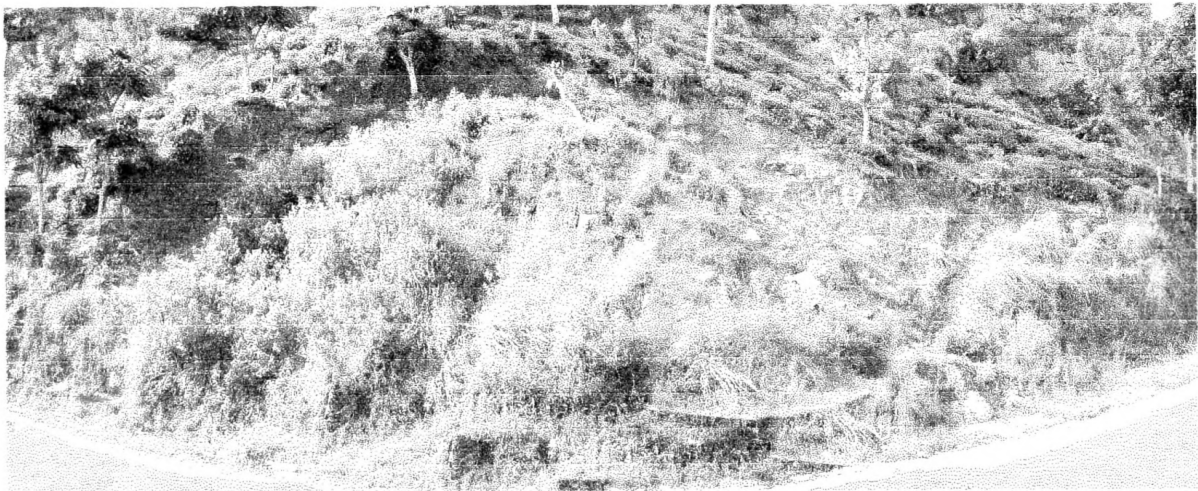
Plate 4.4 :- Minor land slide occurred in a poorly managed tea plantation.

With the increment of new constructions and land involvements, there are numerous bad land use practices prevailing in the area. Tea plantations that were well managed earlier, are poorly managed now. Poor soil conserving practices, over-exploitation of land and no proper treatment exists in association with these cultivated lands. As a result of these mal-practices those lands may become future landslide prone areas. (Plate 4.4)

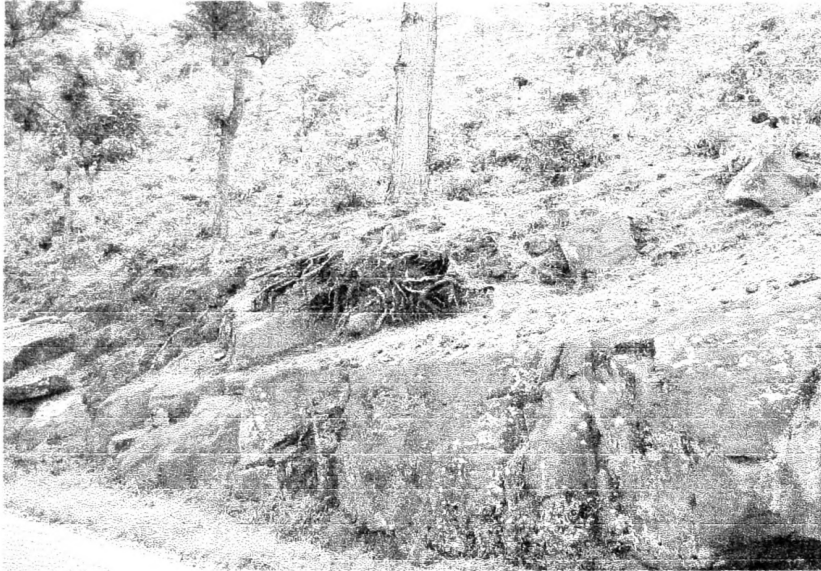
Plate 4.5 :- Soil erosion observed in a poorly managed tea plantation

The high rate of soil erosion takes place on exposed surface boulders and rocks, and with the heavy rainfall, those boulders and rocks can roll down over the slope forming rock-falls (Plate 4.5). Rock-falls are frequent in this area.

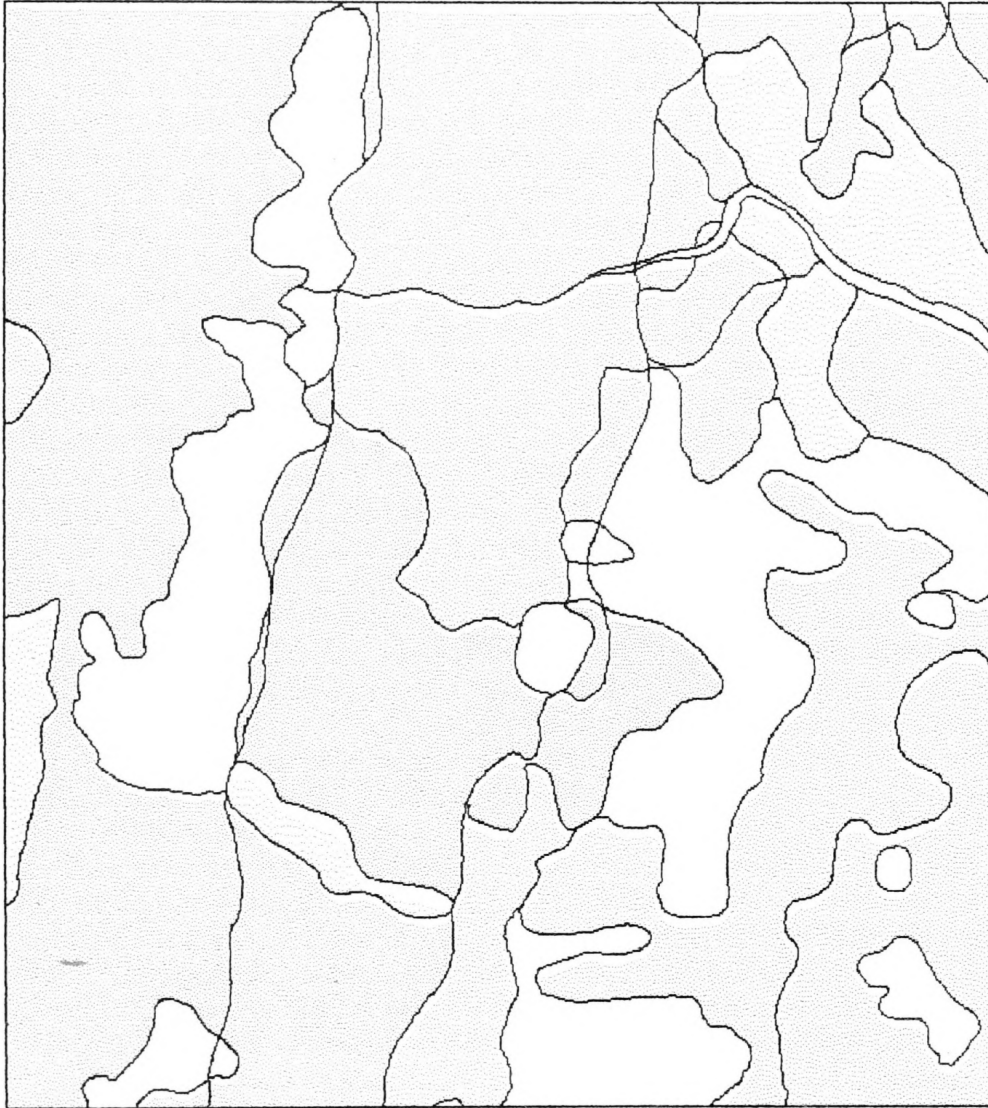
- Landuse & Management 1994
-   Barranlands
 -   Degraded Forests
 -   Forest Plantation
 -   Grasslands
 -   Homestead Agroforestry
 -   Scrublands
 -   Streams
 -   Tea Estate (Poorly Managed)
 -   Tea Estate (Well Managed)
 -   Terraced Paddy

1. The 3 base maps which represent the state of year 1994, under three different categories of,
 - Land-use and Management (Figure 4.1)
 - Human Settlements and Infrastructure (Figure 4.2)
 - Landslide (Figure 4.3)
2. The 3 base maps which, represent the situation in the year 2006 under the same three categories. (Figure 4.4 , Figure 4.5 & Figure 4.6)
3. Contour map of the study area was prepared to show the slope gradient (Figure 4.7).

1. The three base maps which represent the state of year 1994, under three different categories of Land-use and Management (Figure 4.1), Human Settlements and Infrastructure (Figure. 4.2) and Landslide map. (Figure 4.3)
2. The three base maps which represent the situation in the year 2006 under the same three categories in Land-use and Management (Figure 4.4), Human Settlements and Infrastructure (Figure. 4.5) and Landslide map. (Figure. 4.6)
3. Contour map of the study area was prepared to forecast the results and show the category of slope gradient (Figure.4.7).

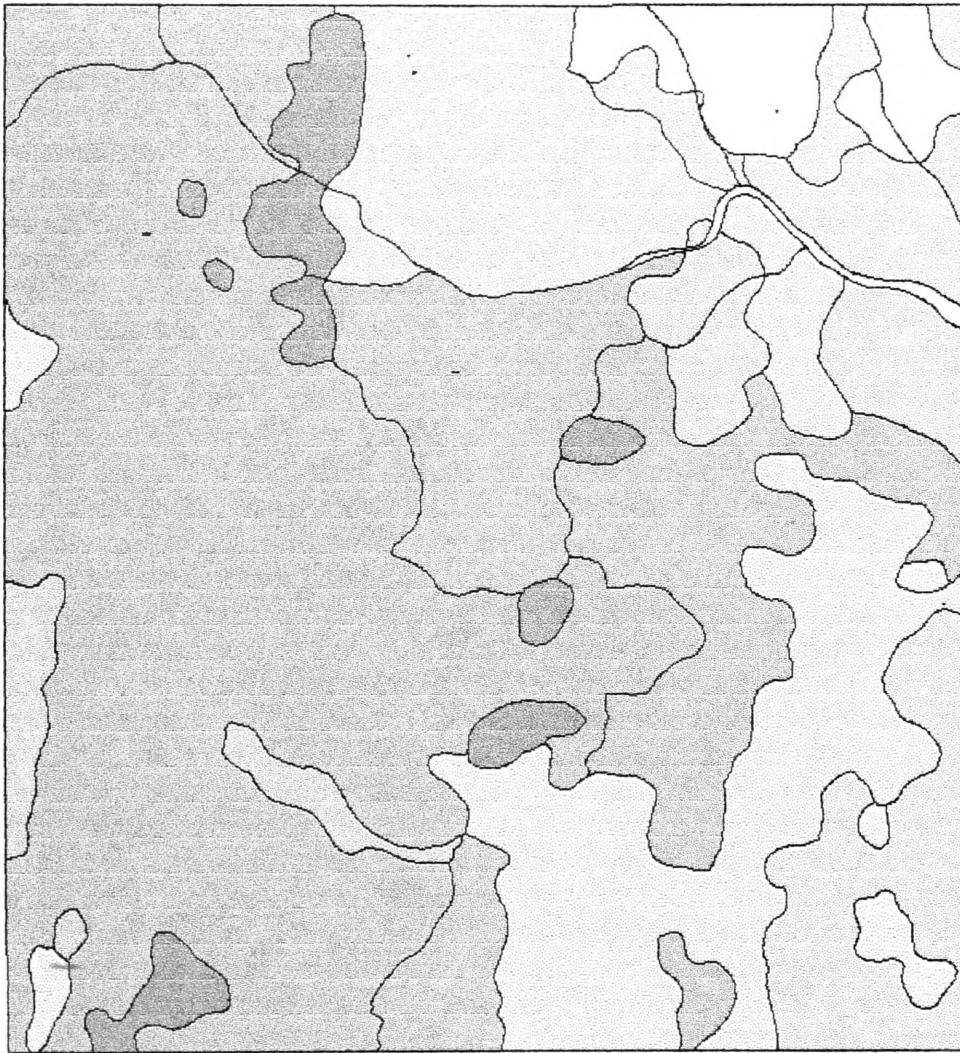
- human Settlements & Infrastructure.
- Estate Settlement
- Homestead Annual Crops
- Homestead Perennial Crops
- Natural Forest
- Paddy Cultivation
- Plantations
- Recently Occupied Homestead
- Rocky land
- Sparsely used Cropland
- Stream

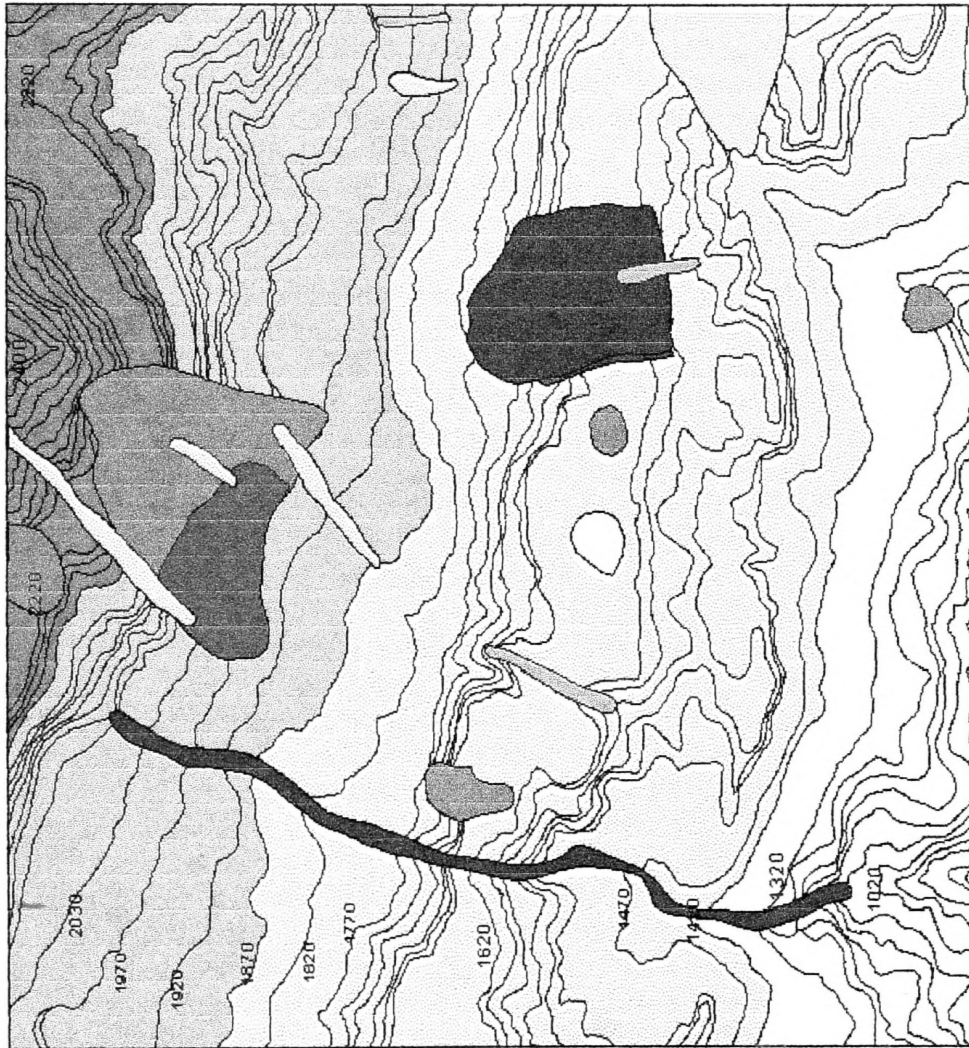
Figure 4.3 : - Landslides map in the year 1994

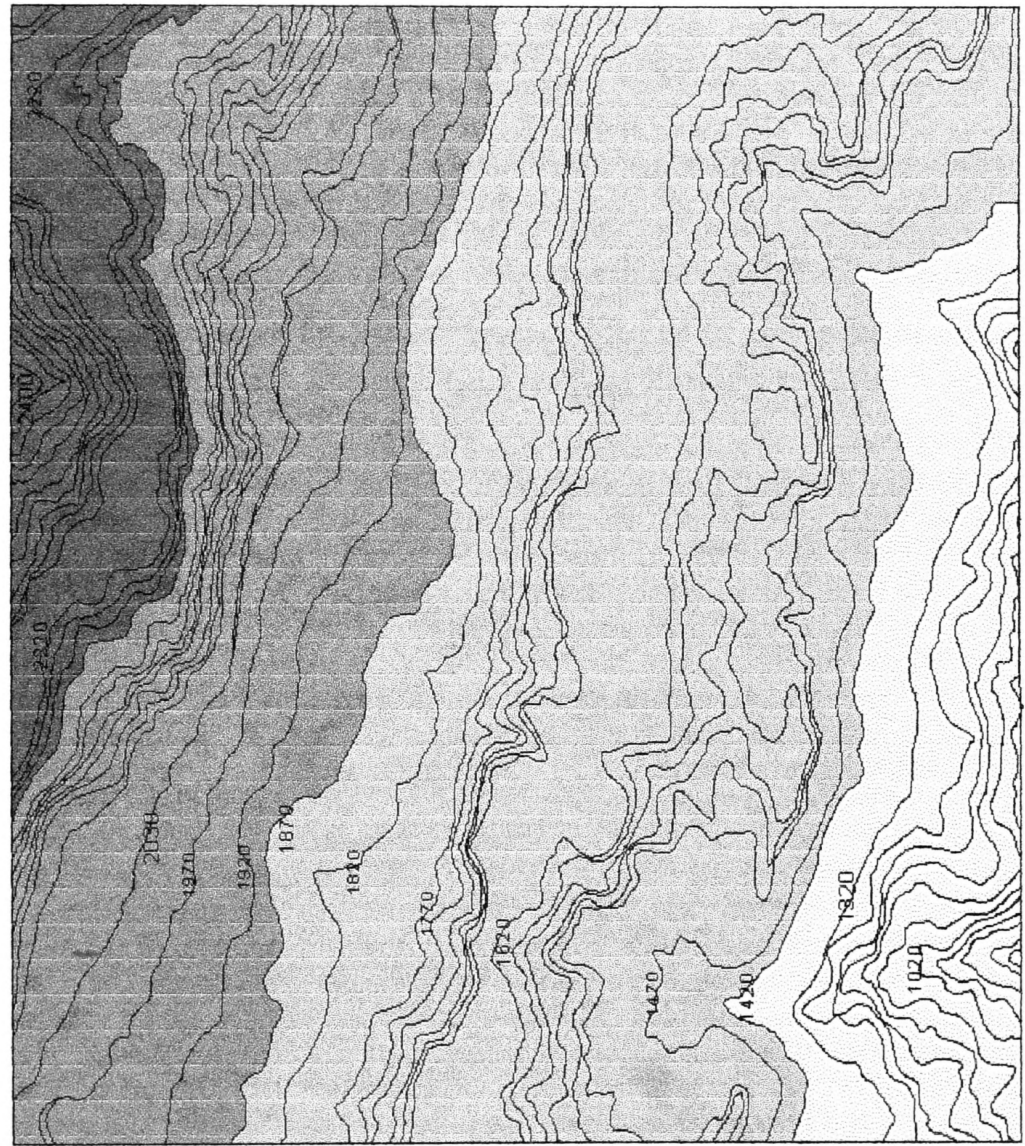
Topographical Map

Contour distance

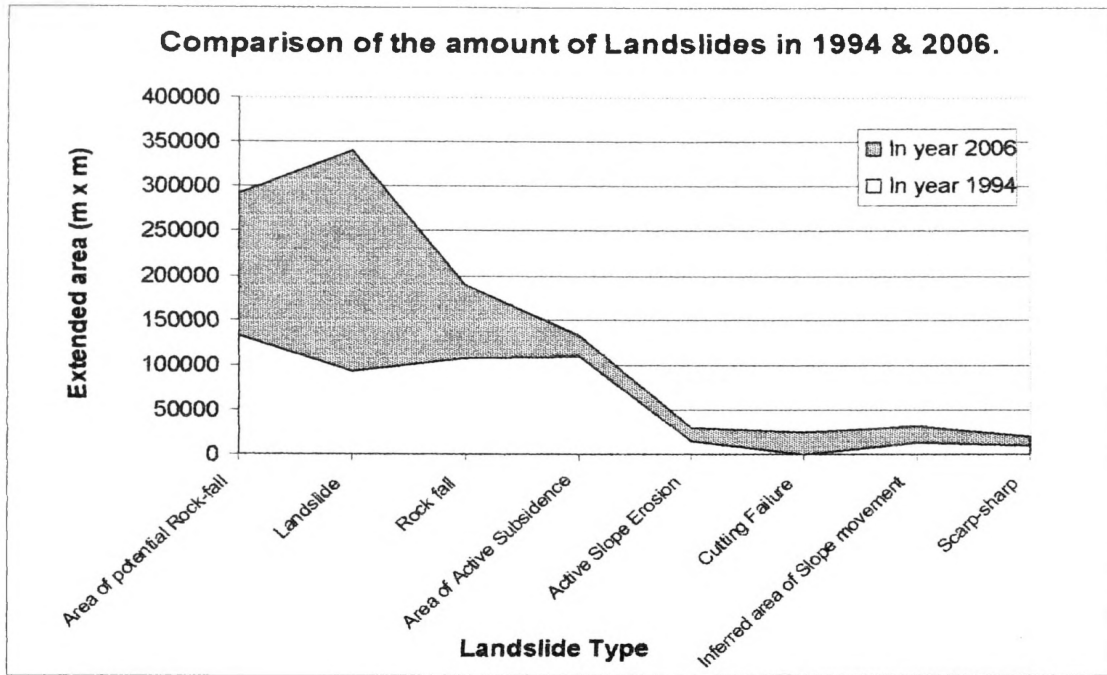
Figure 4.10 :- Comparison the Effective area of landslides in the year 1994 & 2006.
