SAMANALAWEWA HYDROELECTRIC PROJECT

THIRD PARTY REVIEW PANEL

REPORT SMW-1

MAIN CONCLUSIONS AND RECOMMENDATIONS

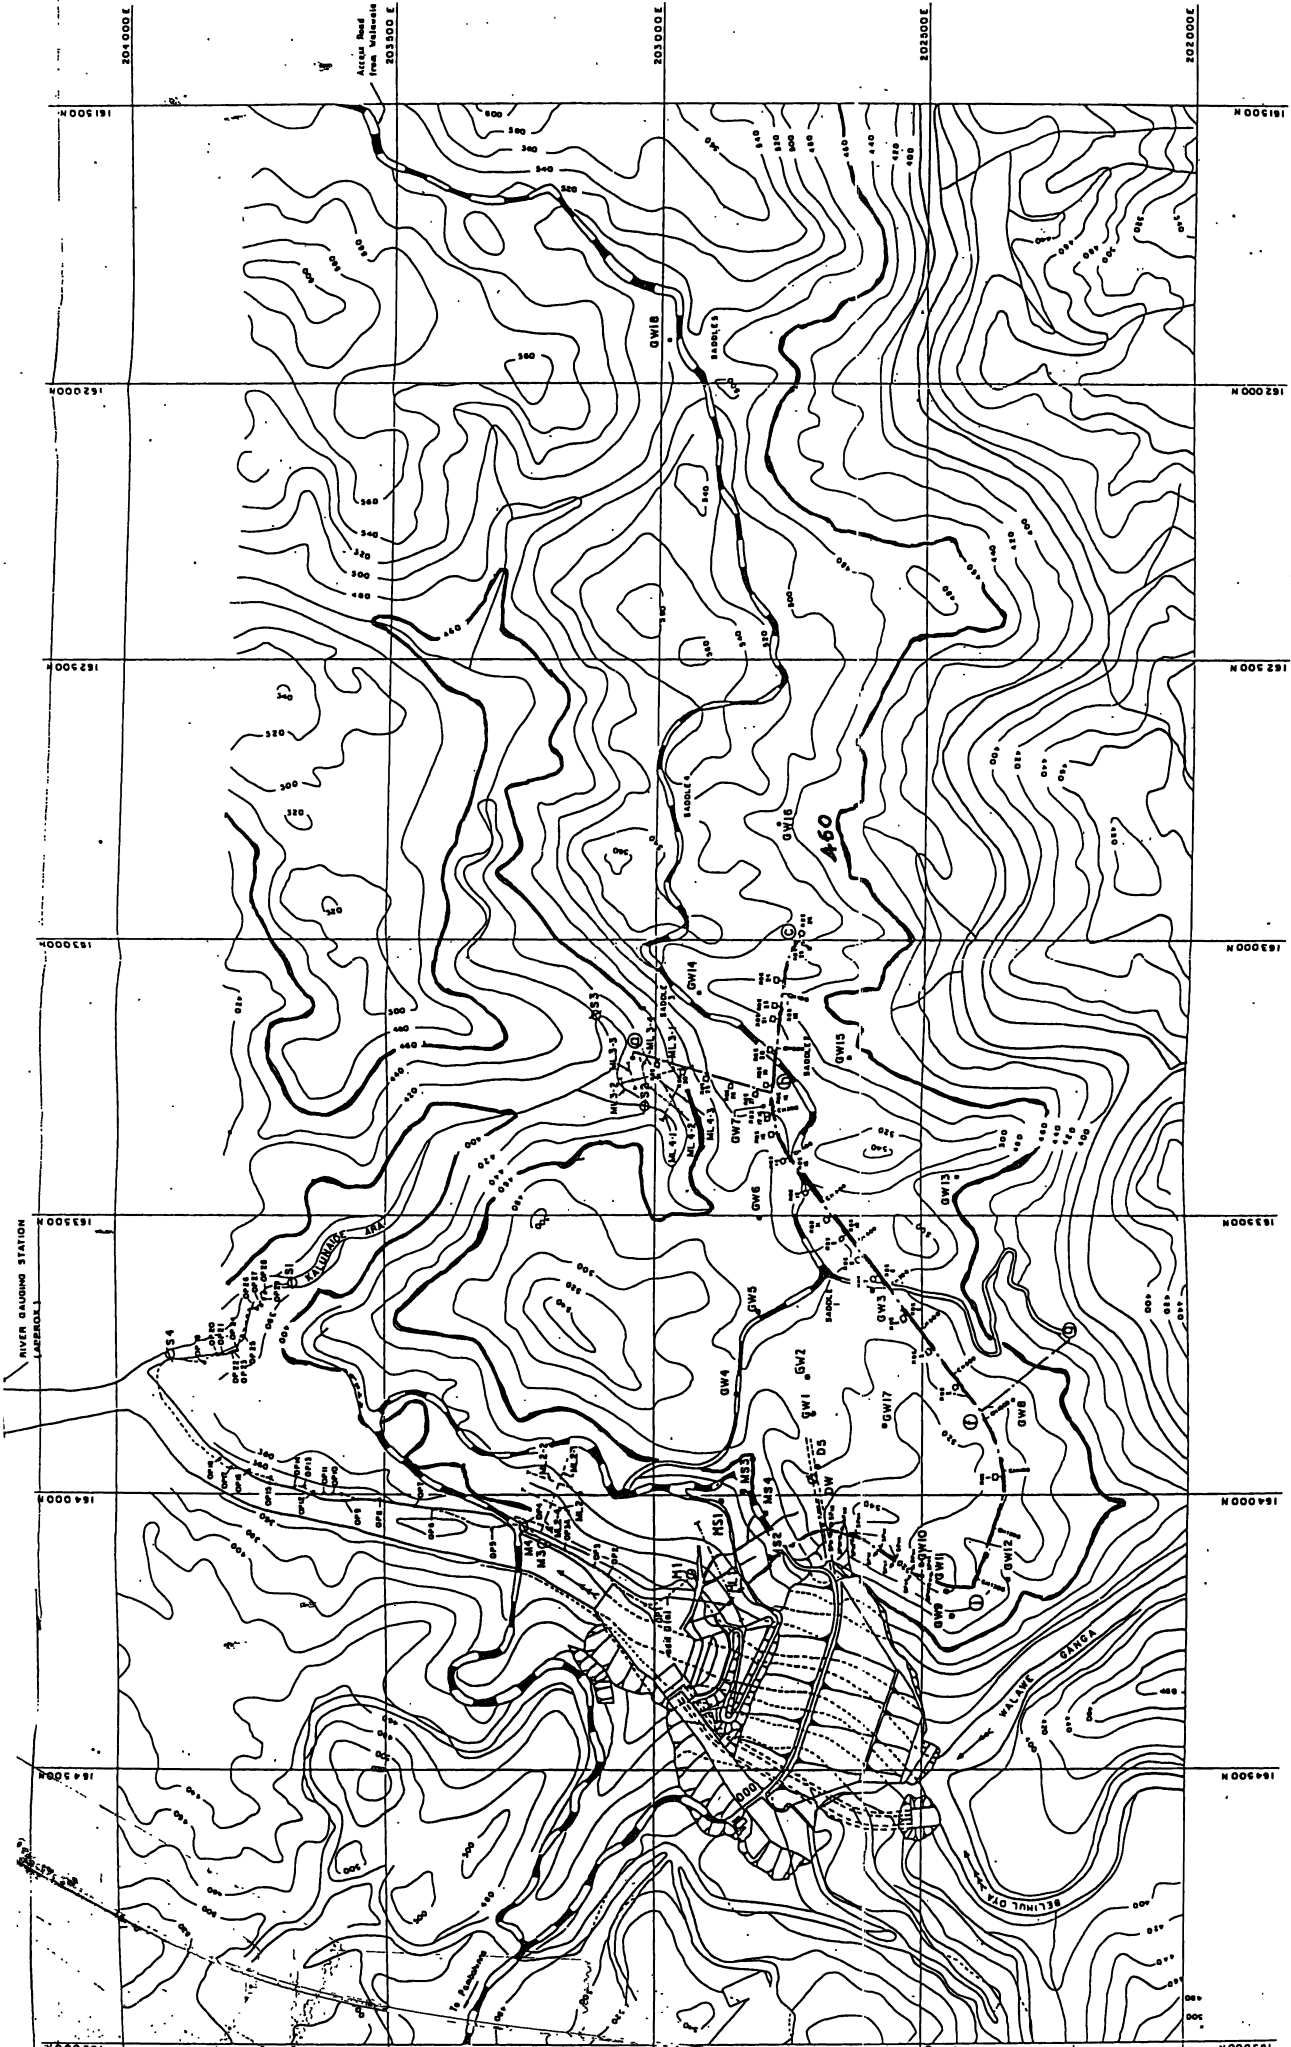
RIGHT BANK
 RIDGE
 1/10000

The right bank is formed by a long ridge with a number of saddles (5) with the fifth one about 2 km south of the dam abutment (see figure 1).

The slightly higher GWT in GW6 may show the proximity of a recharge area : F2 may provide connections to the thalweg of Kalunaide Area downstream of saddle 2 (see figure 1).

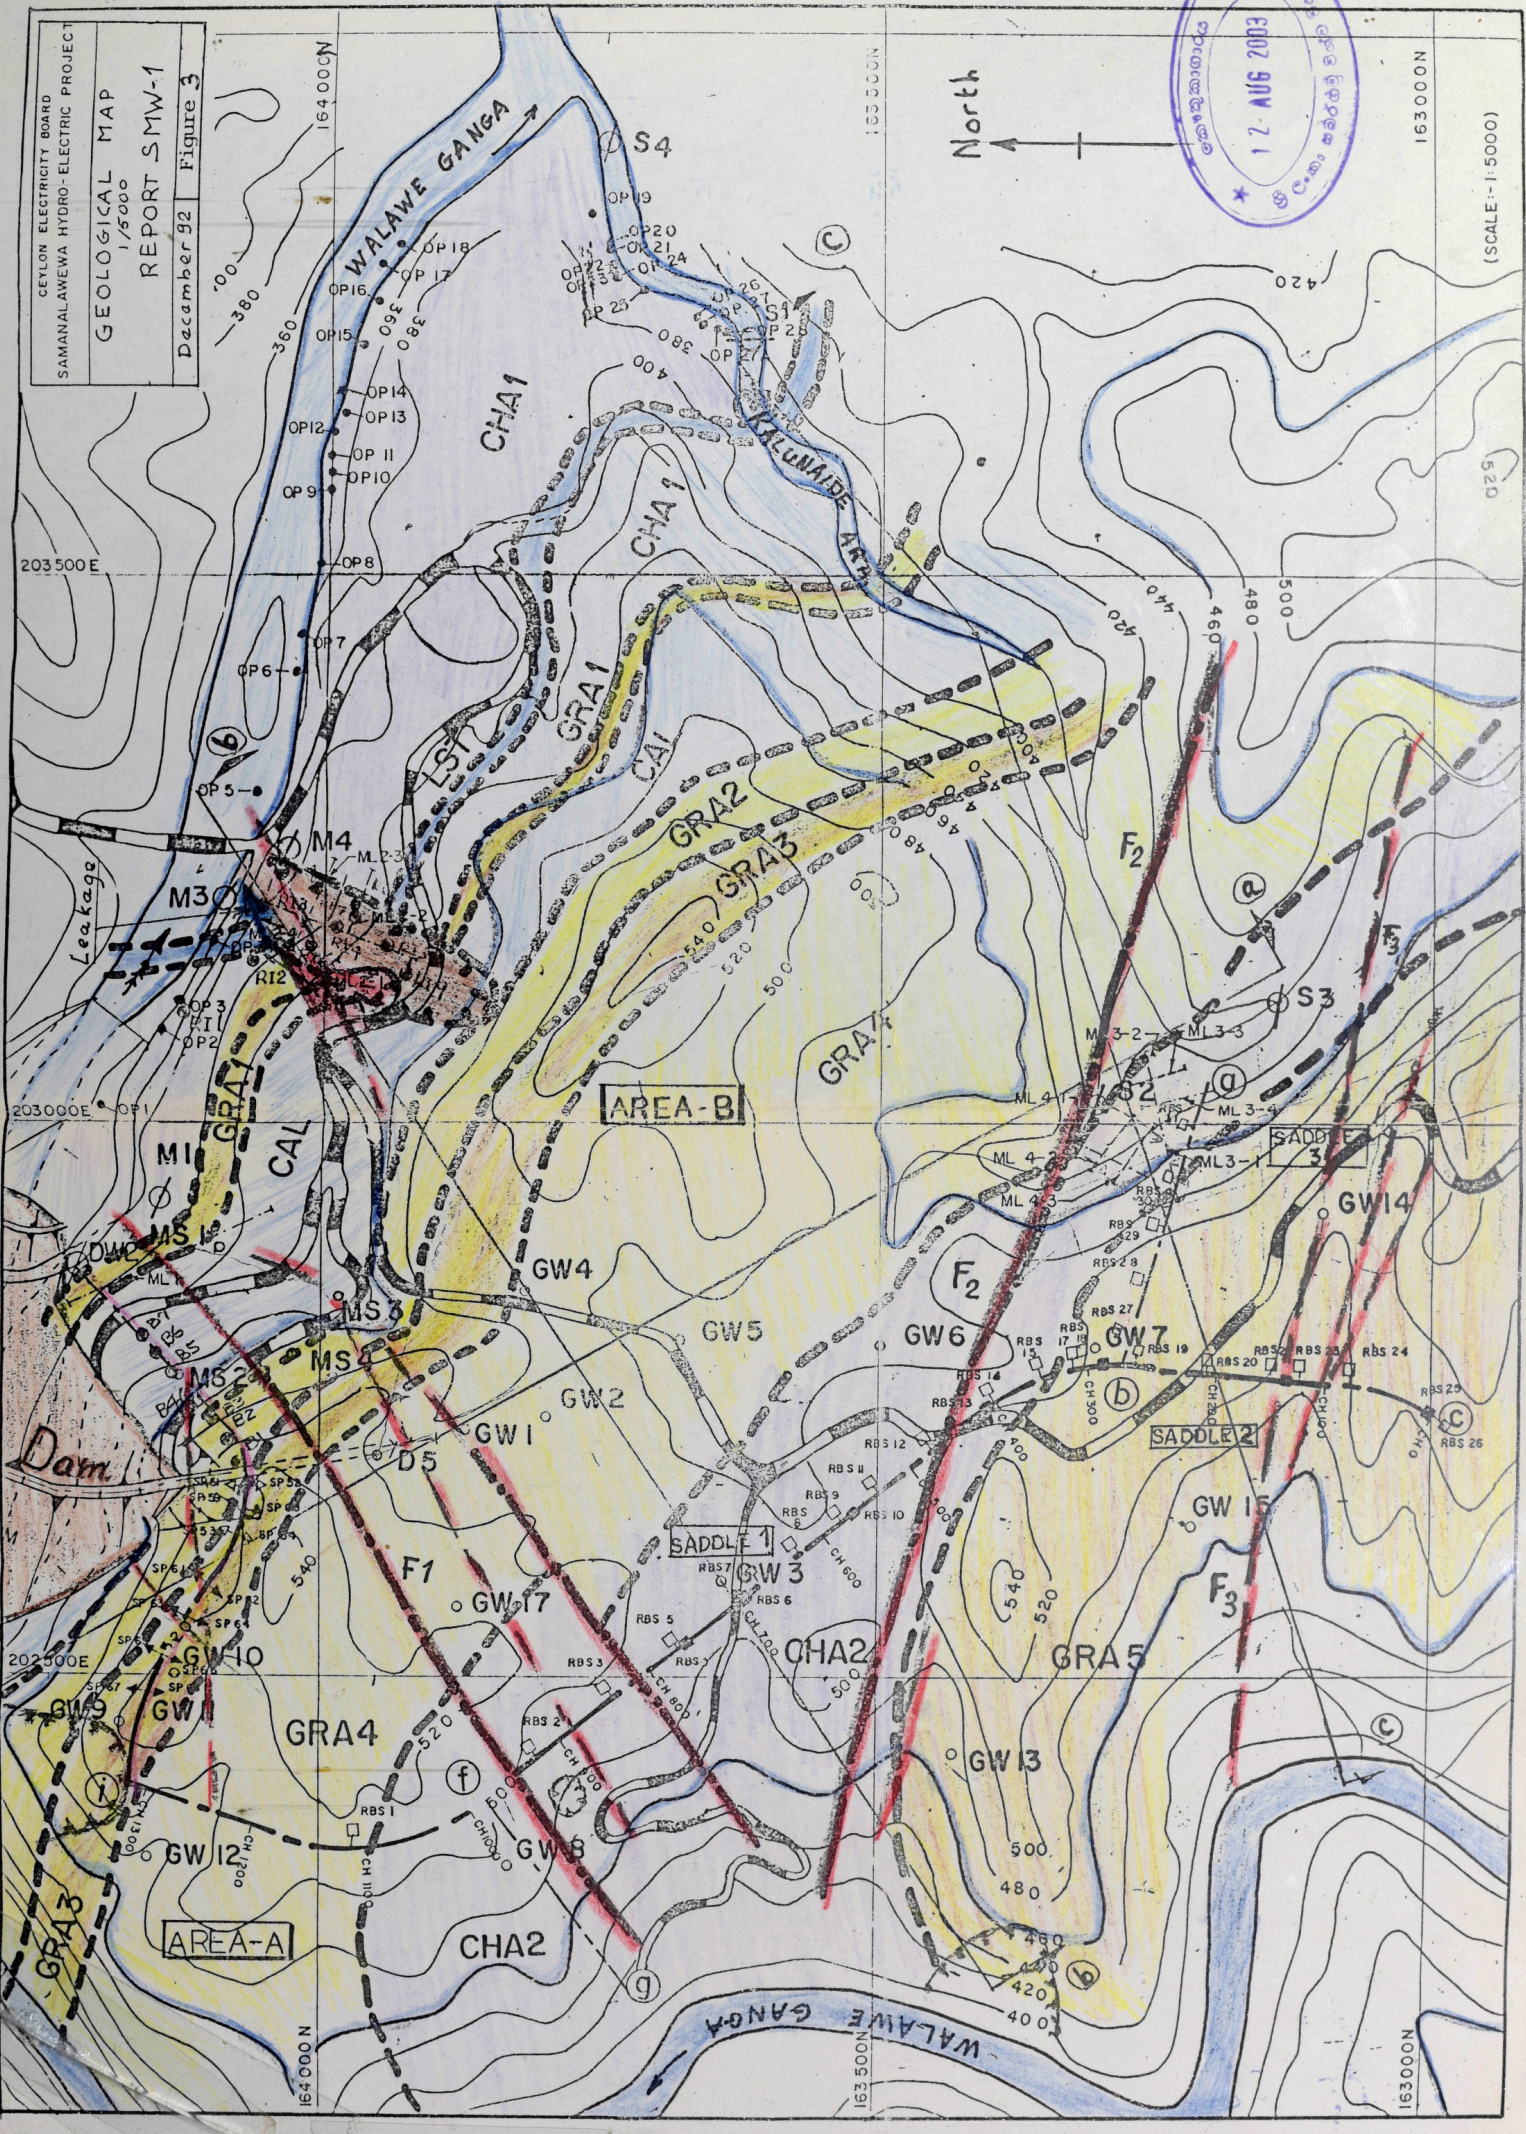
FIGURE 6

Only very few spots have been grouted above the adit up to El. 424 and rarely to El. 460 (see figure 6), taking into account the geological data collected in the adit (areas with open fractures, fault and shear zones) but it is not sure that ungrouted windows have not been left. Certain sections between CH 1200 and CH 1315 have not been grouted, being considered impervious. Check holes or observation wells equipped with a slotted plastic pipe should be drilled to control this extrapolation. Grouting has reduced the void ratio of the curtain by up to 95 %.

Special attention should be paid to the evolution of piezometers in the immediate vicinity of the Dam Right abutment which can be by-passed by the leakage route I bis (see figure 6 bis) using shear joints and tensional fracture joining Fault system F₁. It should be noted that certain of the piezometers (see document C annex fig. J-10 and J-11) placed upstream and downstream of the grout curtain Db have been affected

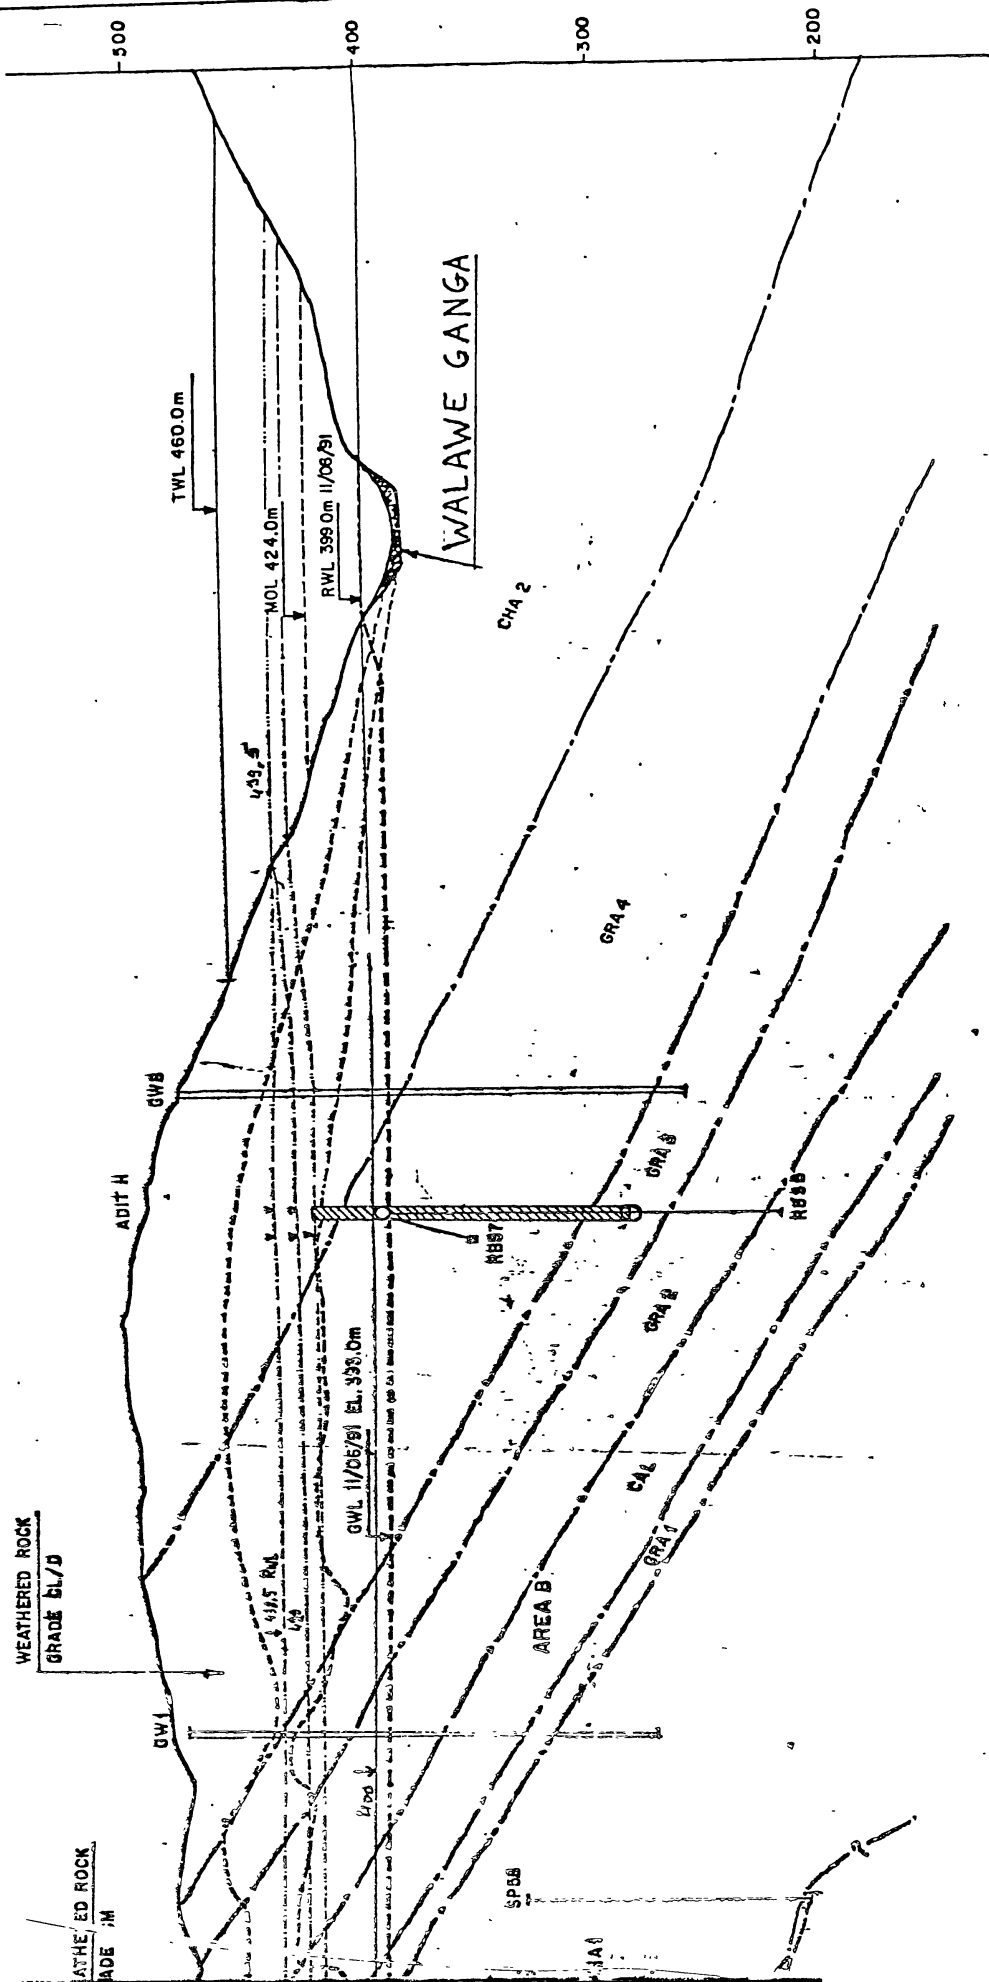
December 92 Report SMW-1
G. Piant - P. Londe FIGURE 7

E-W RIGHT BANK SECTION
ALONG POSSIBLE LEAKAGE ROUTE
