**DETERMINATION OF MAJOR CAUSATIVE FACTORS OF
LANDSLIDES AND LANDSLIDES PRONE AREAS IN KEGALLE
DISTRICT**

This thesis is submitted in partial fulfillment of the report for the degree of

Natural Resource

**Department of Natural Resources
Faculty of Applied Sciences
Sabaragamuwa University of Sri Lanka
Buttala.**

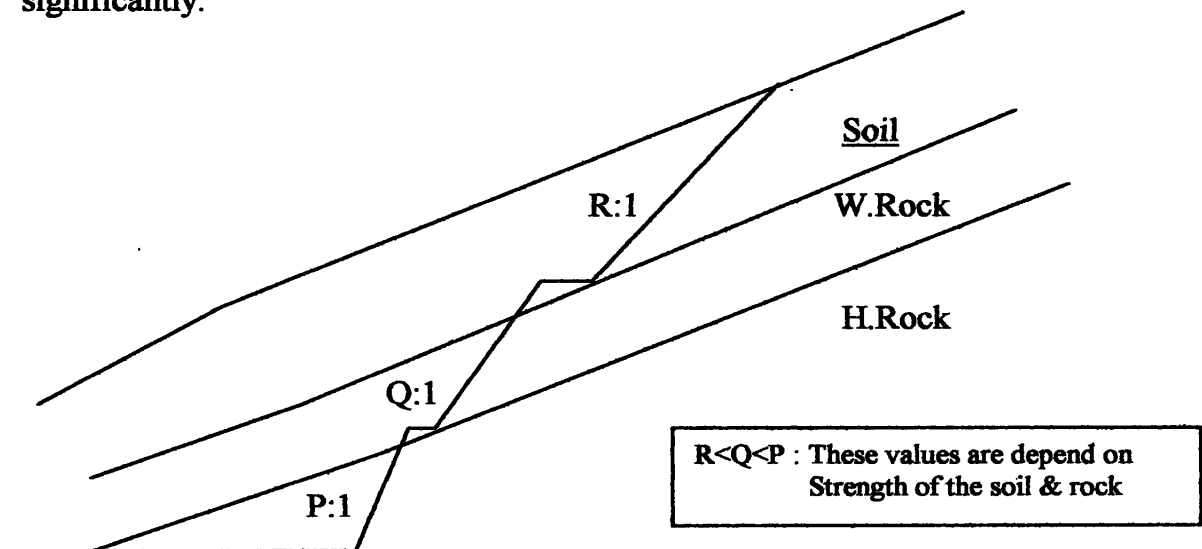
- j) Trenches, for example for services, excavated on or above slopes provide a location where water infiltration into the hillside could eventually lead to slope instability. A trench cut into the toe of a slope can also undermine its stability and should be avoided. Trenches loosely backfilled with soil will act as sumps for rainwater and should not be allowed.
- k) Variable angle slope designs are usually more effective and economical in cut slopes. By using this method volume of earthworks can be reduced significantly.

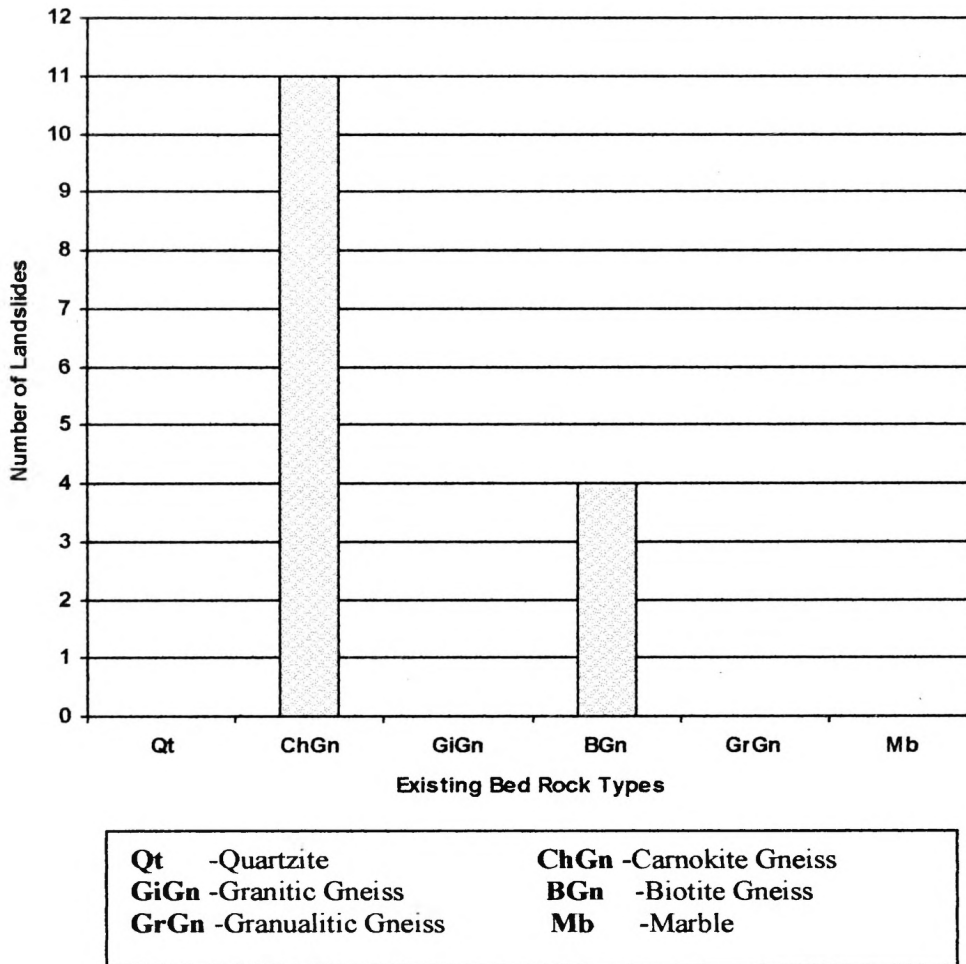
Fig 4.1. The Graph of Number of Landslides VS Existing Bed Rock Types

Kegalle district is entirely underlain by pre Cambrian metamorphic rock of highland series. Charnokite gneisses, Biotite gneisses, Hornblende-Biotite and Metasediments are a characteristic lithology of the highland series. (Corey, 1984) During the investigated period, this lithology was identified on the basis of its characteristics in outcrops and using hand specimens only.

Fig.4.1 Show the relationship between different bed rock lithologies VS number of investigated landslides in Kegalle District. It is clearly shown that, prominent bed rock lithology of investigated areas is Charnokite gneisses rock. Eleven landslides out of the fifteen investigated within the district is underlain by the rock identified as Charnokite gneiss. Biotite gneisses is associated with four investigated landslides. Other rock types were not found in association with investigated landslides. Quartzite is found in some investigated area in small quantities as small intrusion in major Charnokite and Biotite Gneisses rock.

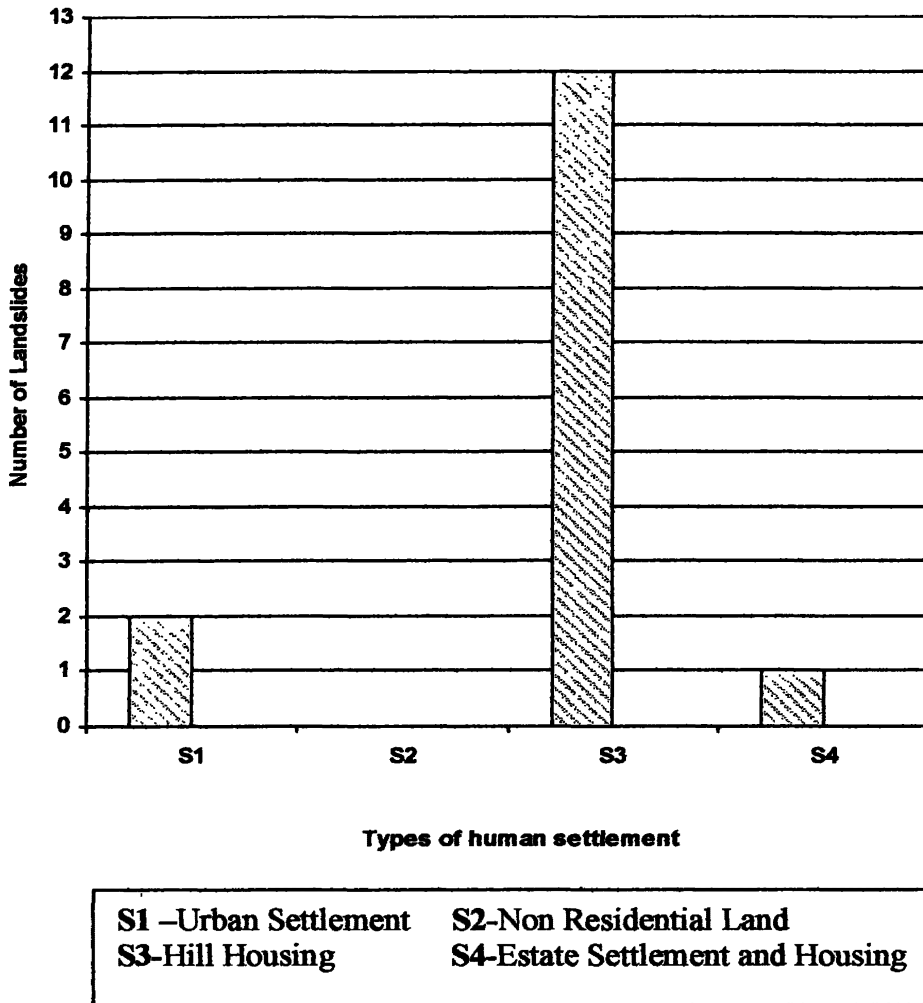
Fig.4.4.The Graph of Number of Landslides VS Types of Human Settlement

Fig.4.4 shows the graphical representation of the relationship of human settlement types VS the number of landslides occurred in the district of Kegalle. The highest rate of landslides has been recorded in the areas where hill houses exists. This is the characteristic feature, which is found from investigation, because every investigated hill slope area could be seen with human settlements. On some slopes, well built houses existed and on other places small cottages could be observed. But urban settlements were record only in two investigated places. The results shown in figure 4.4 can be attributed to following factors

- b. Poor construction methods applied for construction of infrastructure. Most of the roads construction in hill slopes of the district of Kegalle, are come out without performing a detailed geological study. Some road cuts have been made in places where rock layer is inclined forward to the slope. Such cut slopes become unstable causing severe damages to human lives and their properties.
- c. Other cause is that extremely unsuitable high slopes areas are used for construction of houses. This is directly prone to mass movement of Kegalle district. This type of construction could be found in all investigated areas.

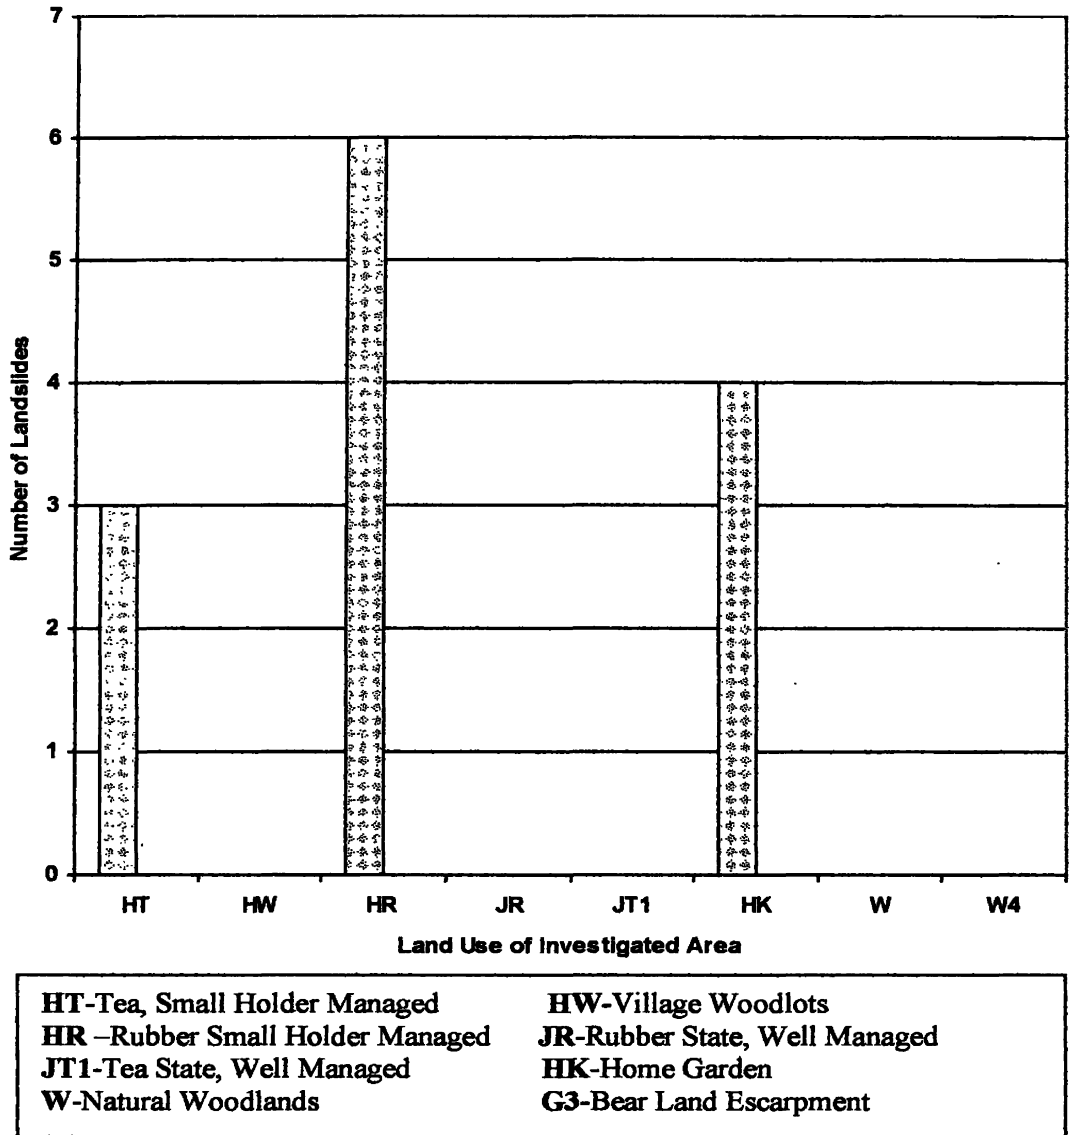
Fig.4.5. The Graph of Number of Landslides VS Types of Land use Practices

Fig.4.5. graphically represents the main land use practices in Kegalle district VS number of landslides that area has undergone. The highest rates were recorded in association with small holder managed rubber cultivation. Secondly, home gardens and small tea cultivated areas had undergone a certain number of landslides. Considering the investigated area a lot of mass movements have occurred in rubber and tea cultivated hill slopes. Following factors cause the increase in vulnerability of rubber and tea cultivation on slopes in Kegall district.
